IMPORTANT - Please read this BEFORE you install this product!

METER AND VALVE PROBLEMS DUE TO ULTRA-LOW-SULFUR DIESEL (ULSD) DEBRIS

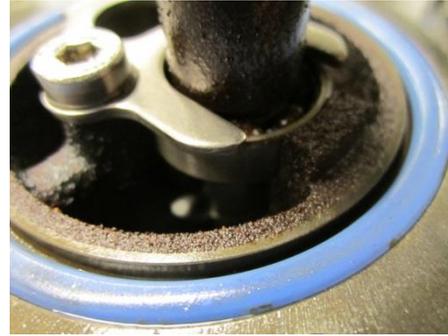
Xflo® meter

Close-up with head removed showing ULSD debris

If any of these symptoms or conditions are present, DO NOT INSTALL a replacement meter or valve! The existing equipment may have been damaged by corrosive (acidic) material produced from contaminated fuel. This condition is particularly prevalent with Ultra-Low-Sulfur Diesel (ULSD). The product piping and equipment must be thoroughly inspected and repaired or replaced before a new meter or valve can be installed. The valves and meters listed above have a low tolerance for ingested debris. A single rust nodule or strand of strainer mesh can jam or damage a meter or valve.

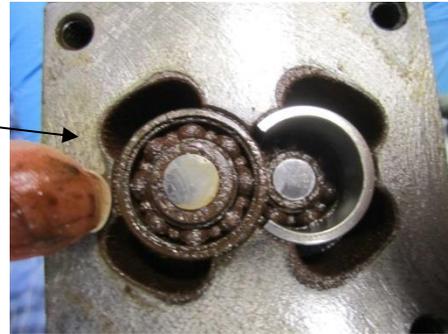
Ecometer®

Close-up with end cap removed showing ULSD debris

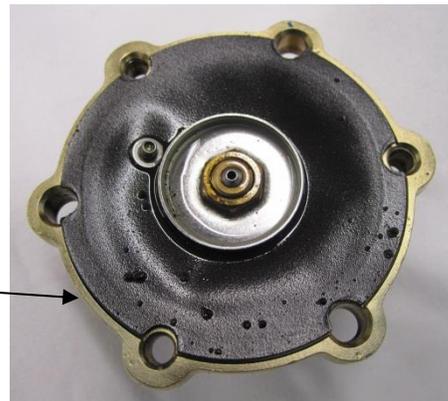
Proportional valve

Close-up of valve diaphragm showing ULSD debris
